BELLAIRE DAM INSPECTION REPORT

**DAM SAFETY INSPECTION REPORT
BELLAIRE DAM
DAM ID NO. 435
ANTRIM COUNTY; INTERMEDIATE RIVER**

INSPECTION DATE: November 2018

REPORT DATE: December 2018

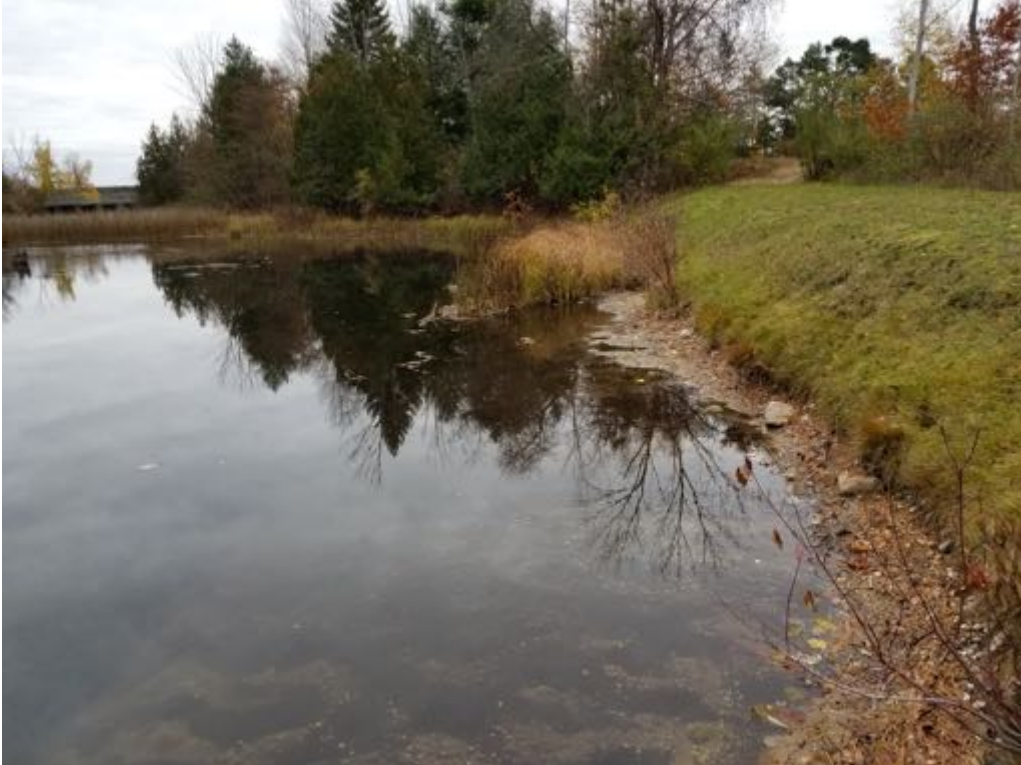
The eastern end of the embankment appears to be in good condition with both the upstream face and the top well vegetated with grassy vegetation. There is no evidence of animal burrows in the upstream face. The sheet piling that forms the east entrance to the spillway is in good condition. There is a small willow that has taken root at the edge of the sheet piling. This willow should be removed before it becomes a problem. Refer to the photograph in the appendix. The downstream face of the eastern end is in good condition and covered with grassy vegetation with a notable exception. There are two large willow trees at the toe of the dam that should be removed to prevent piping from root penetration. A photograph of the trees in question is also noted in the appendix. There is a minimal amount of seepage at the toe of this embankment. This seepage has been constant for several

East end of upstream embankment looking east with small willows that should be removed

1. Remove all woody vegetation from the upstream and downstream embankments.
2. Perform a detailed inspection of the rubber seals on the radial gates, and replace if necessary.
3. Fill cracks in concrete along top of concrete spillway walls, and seal concrete to reduce future damage.

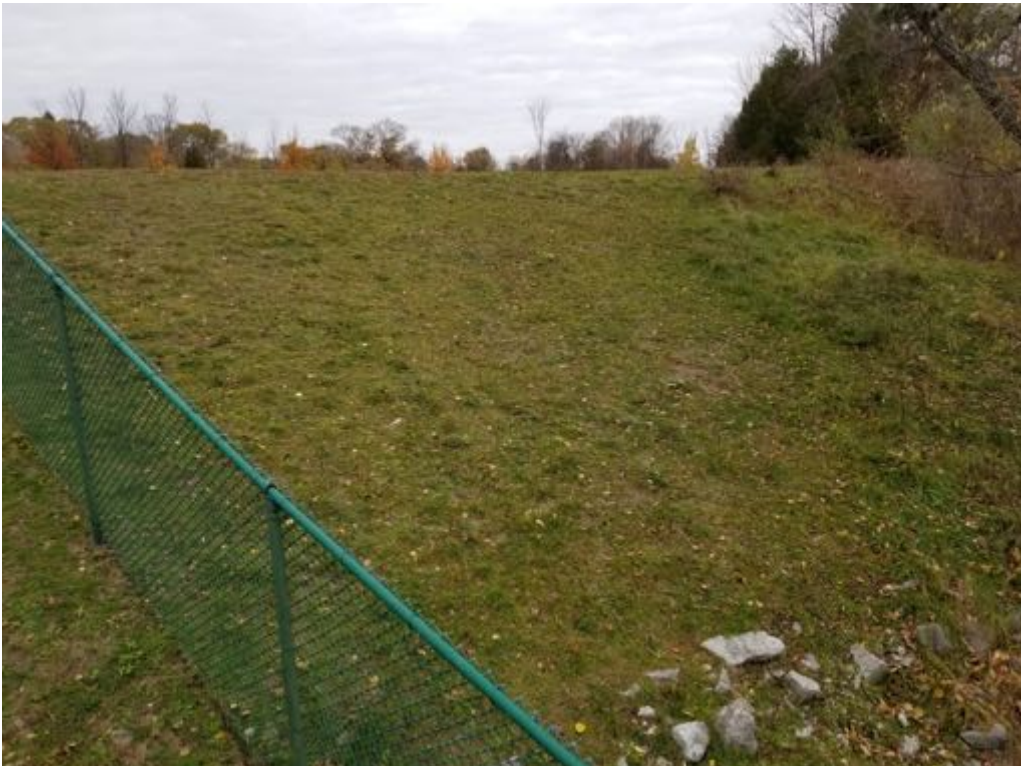
Downstream embankment at east end

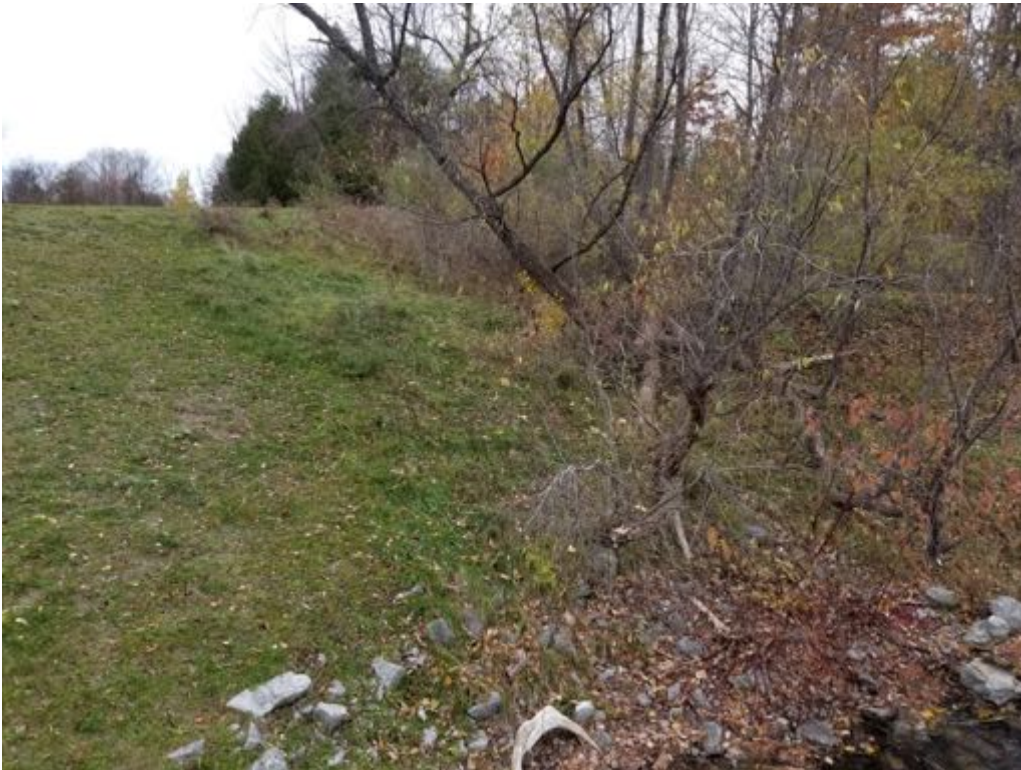
Downstream embankment at east end showing willow trees that should be removed

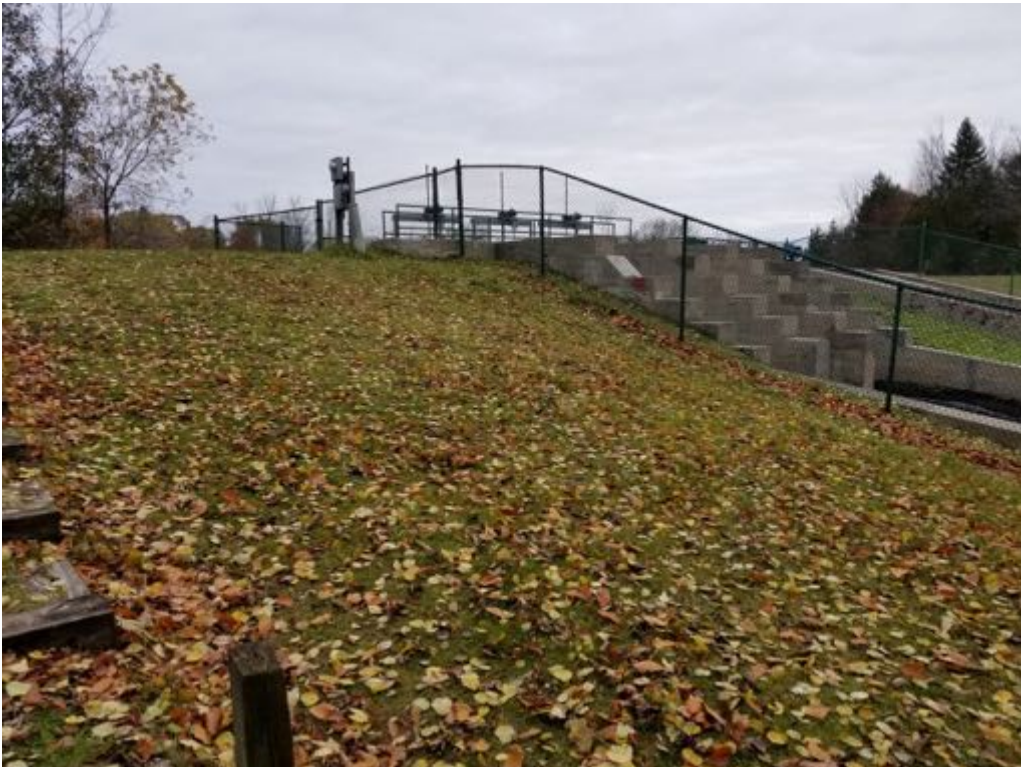
The western end of the embankment appears to be in good condition with the upstream face, crest and downstream face well vegetated with grassy vegetation. There does not appear to be any animal burrows along the upstream face. The sheet piling that forms the western entrance of the spillway is in good condition.

Downstream embankment west end of dam

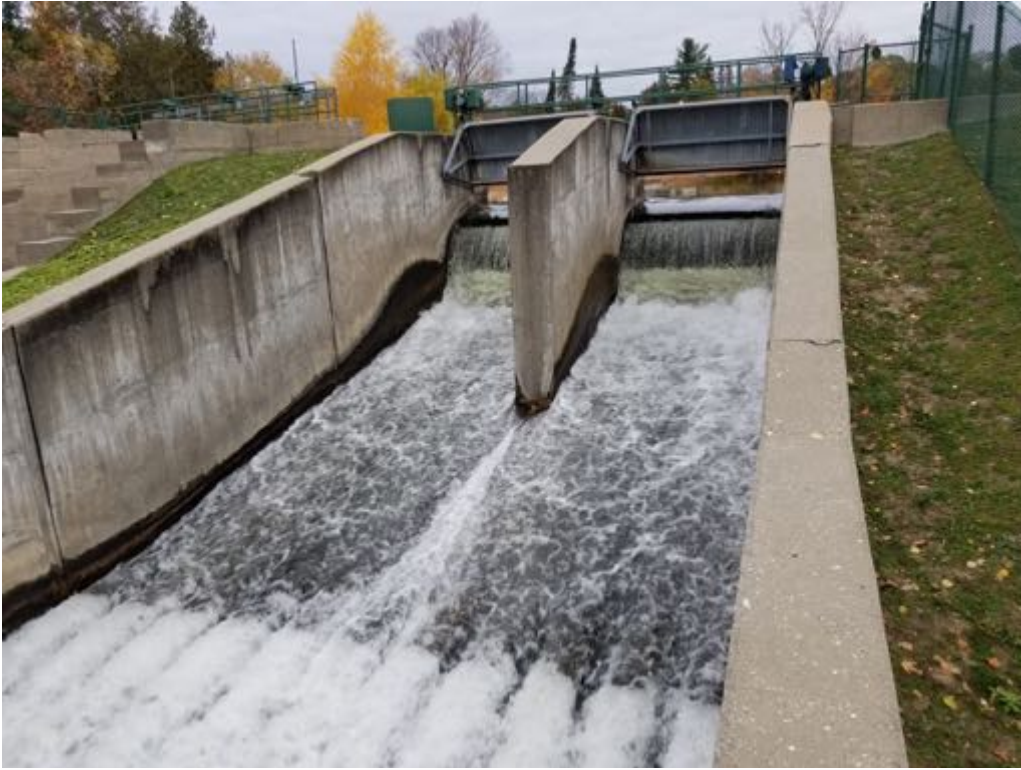
Radial gates looking upstream

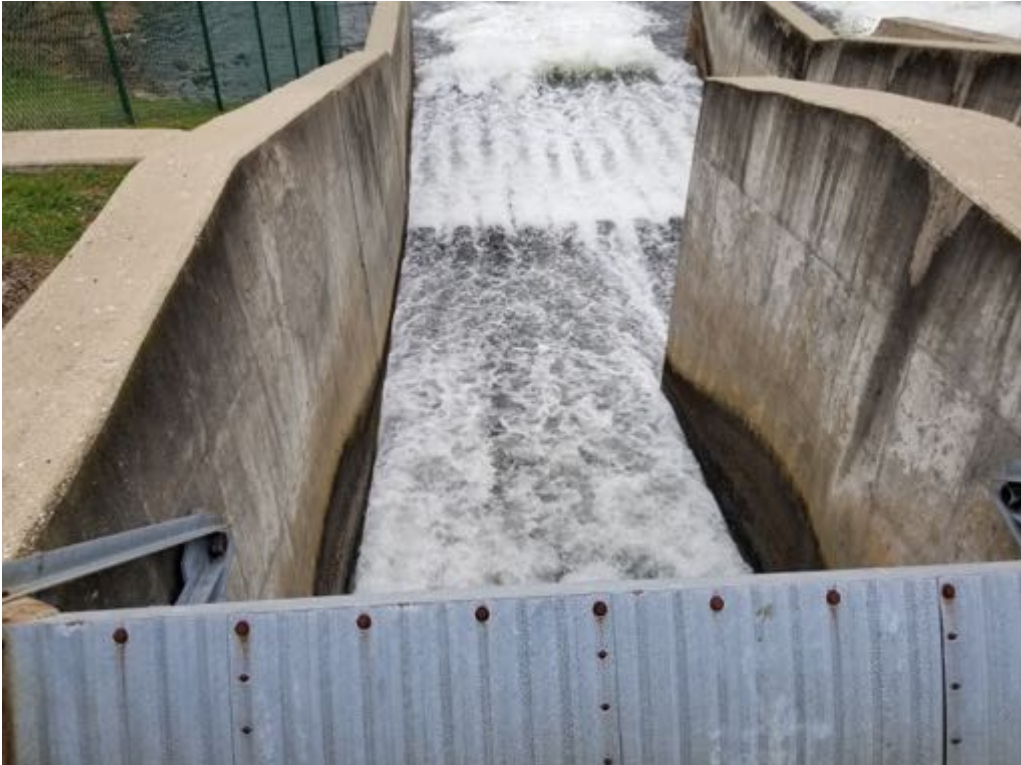
The spillway walls downstream of the radial gates is being eroded and may require repairs in the future to mitigate future damage. Maintenance work on the right three slide spillways to correct severe spalling and leakage around the gates using epoxy and stainless steel has proven very effective. This approach may be considered for the left two radial gates to remedy this issue. The concrete energy dissipation blocks at the bottom of the spillway appear to be in good condition.

Radial gate looking downstream showing erosion on side walls

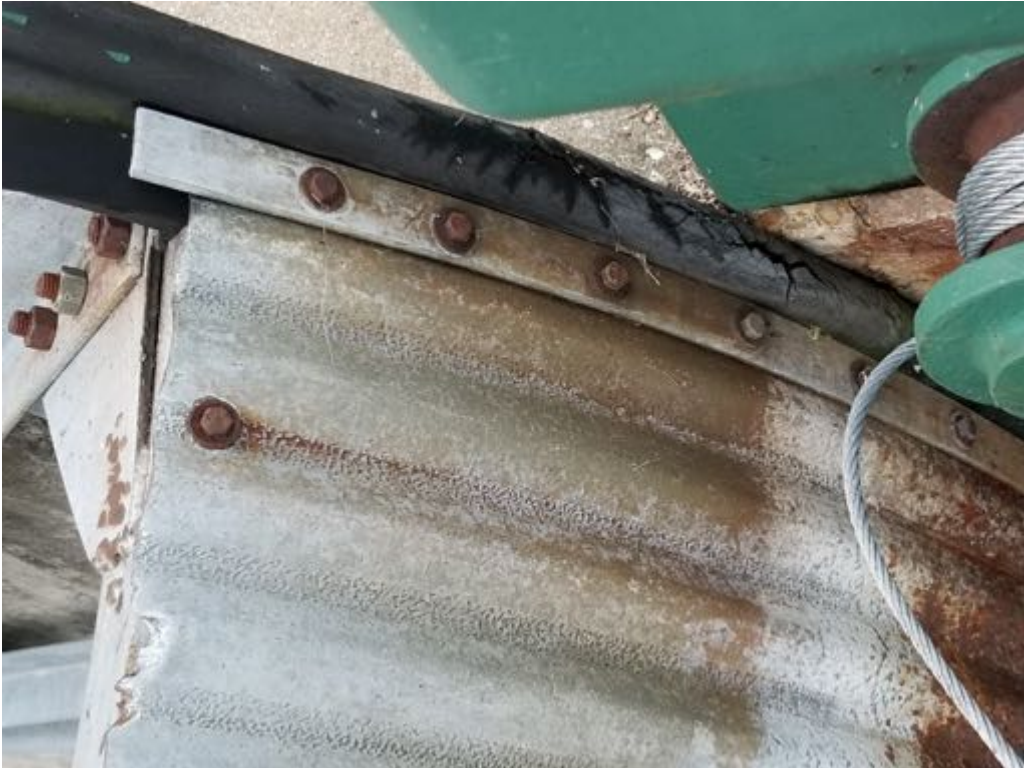
The left spillway was built in 1974 and consists of two bays both controlled by 10 foot wide by 4 foot high radial gates. Both gates appear operational and were open at the time of this inspection. The rubber seal along the edge of both gates is in poor condition and should be inspected more closely. If necessary, these rubber seals should be replaced next summer. Please refer to the photographs for more information. The concrete near the radial gate bearings has eroded, perhaps aggravated by the continual use of depositing feces by raccoons. This concrete should be patched and sealed to reduce water infiltration and spalling. Ongoing efforts to reduce access to this area by raccoons have proven ineffective as the raccoons are easily capable of climbing the fences. If they continue to utilize this spot for a bathroom, it might be wise to contact an animal control expert.

Radial gate showing deteriorated rubber seal along edge of gate

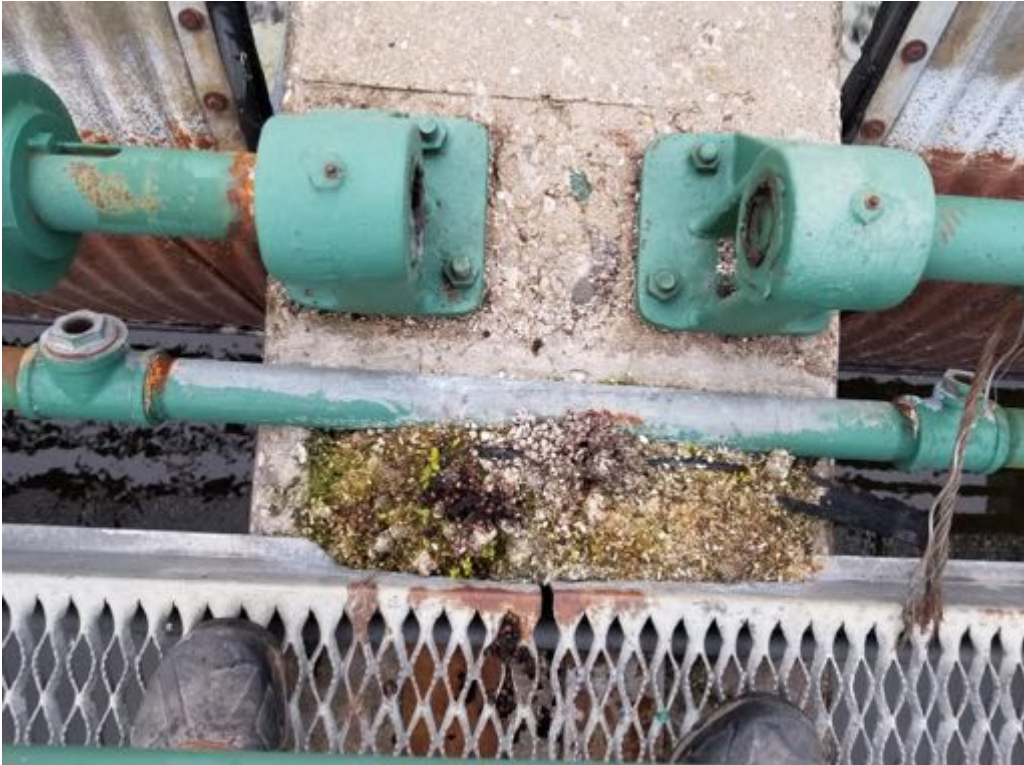
Support section between radial gates showing raccoon feces

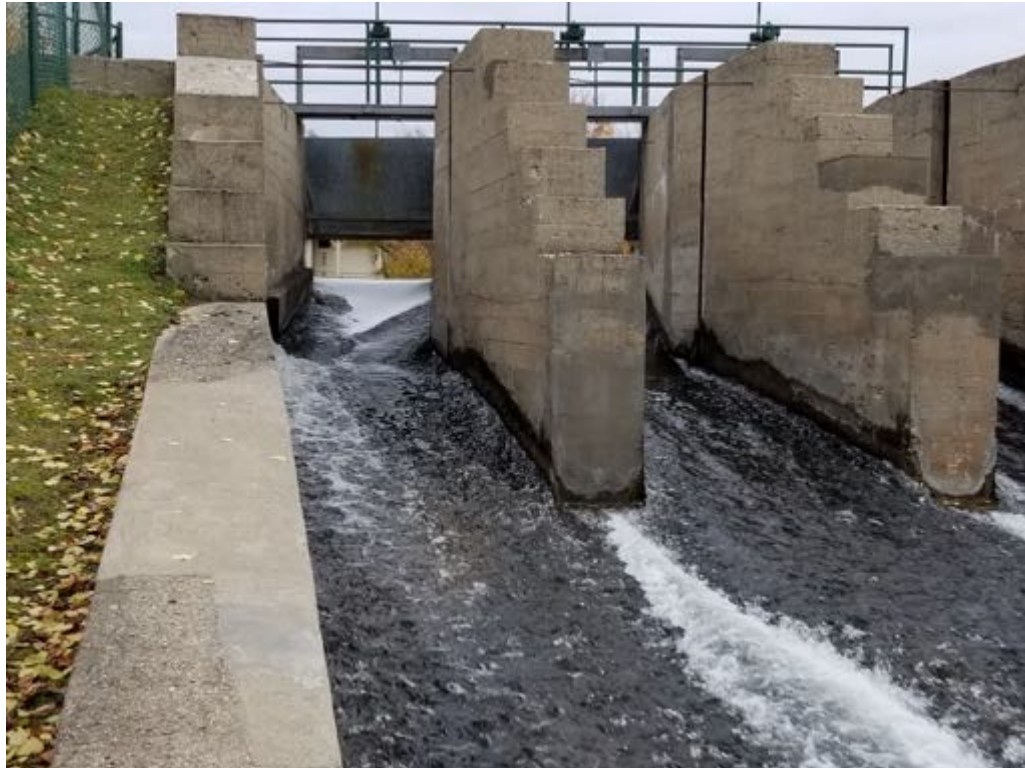
Slide gate discharge chutes

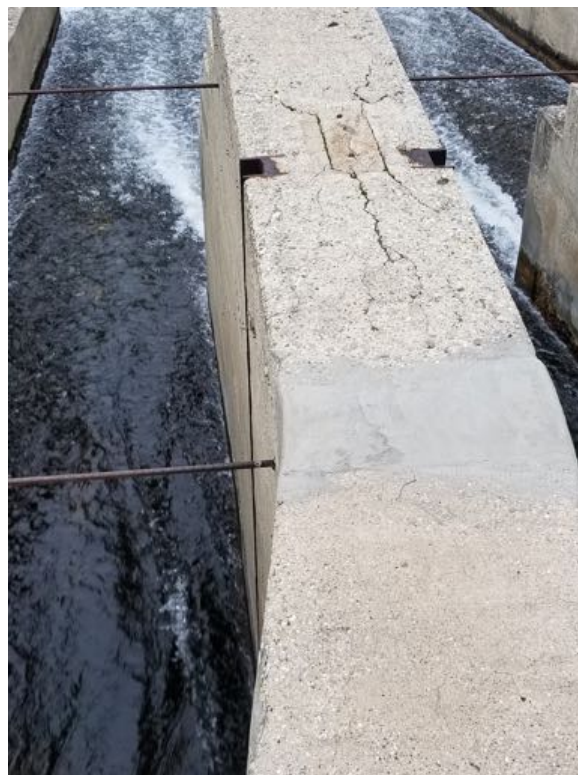
The 2012 report noted the upstream faces of the concrete spillways had significant leakage around the gates as well as serious spalling near the spillway gates. The deficiencies were addressed using a combination of stainless steel to wrap the leading edge of the concrete dividers between the spillways, and epoxy to seal and strengthen the concrete. These repairs appear to have resolved the spalling issues, and appear in good condition on the date of this inspection. There are numerous cracks along the top of the concrete dividers. These cracks should be filled and the tops of the concrete sealed to reduce future damage.

Concrete divider between slide gate discharge sluices showing cracked concrete

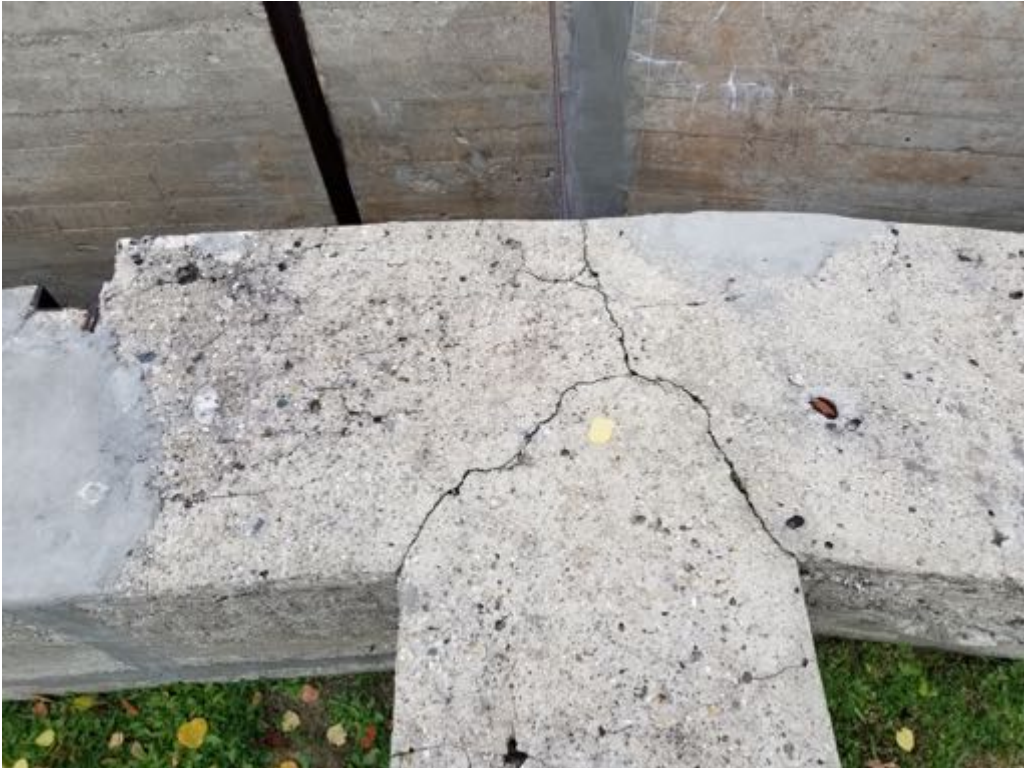
Close up of cracks in concrete that should be repaired and sealed

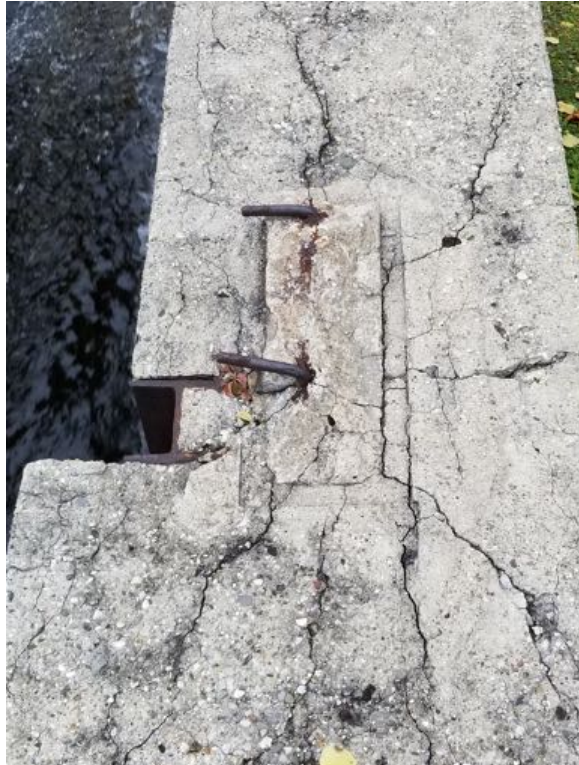
Close up of cracks in concrete that should be repaired and sealed

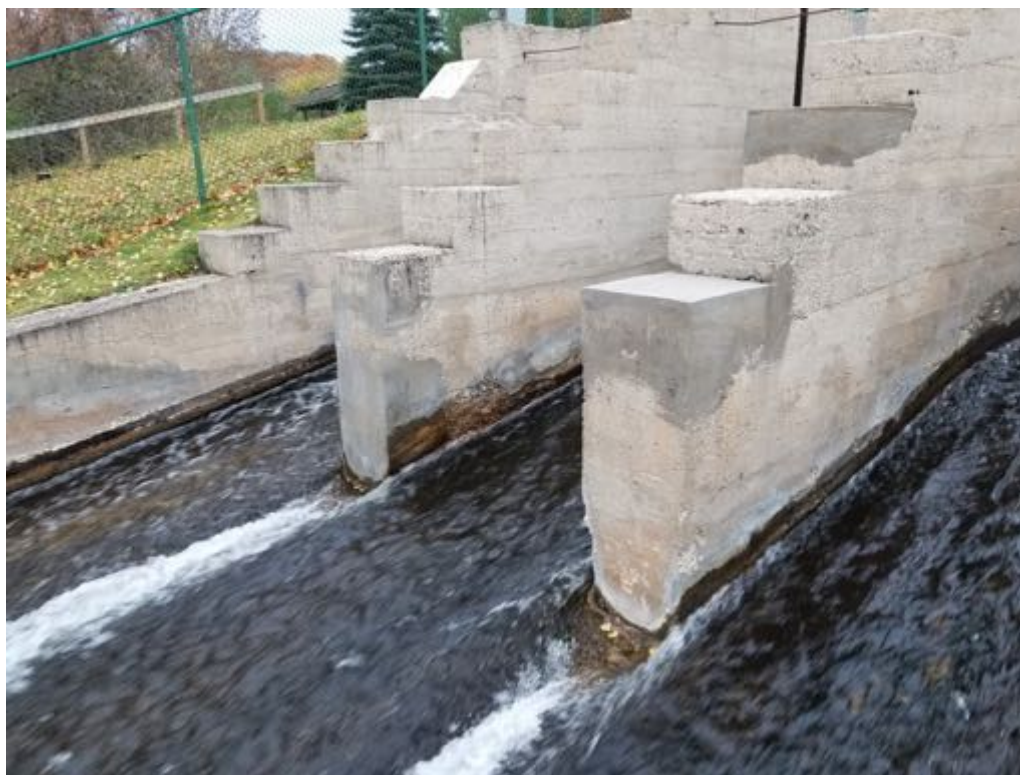
Prior inspection reports noted the spillway walls had been repaired with epoxy to address spalling concrete. These repaired sections continue to be in good condition but should be monitored and appropriate action taken if cracking or spalling reappears.

Downstream walls of slide gate discharge sluice showing repairs in good condition

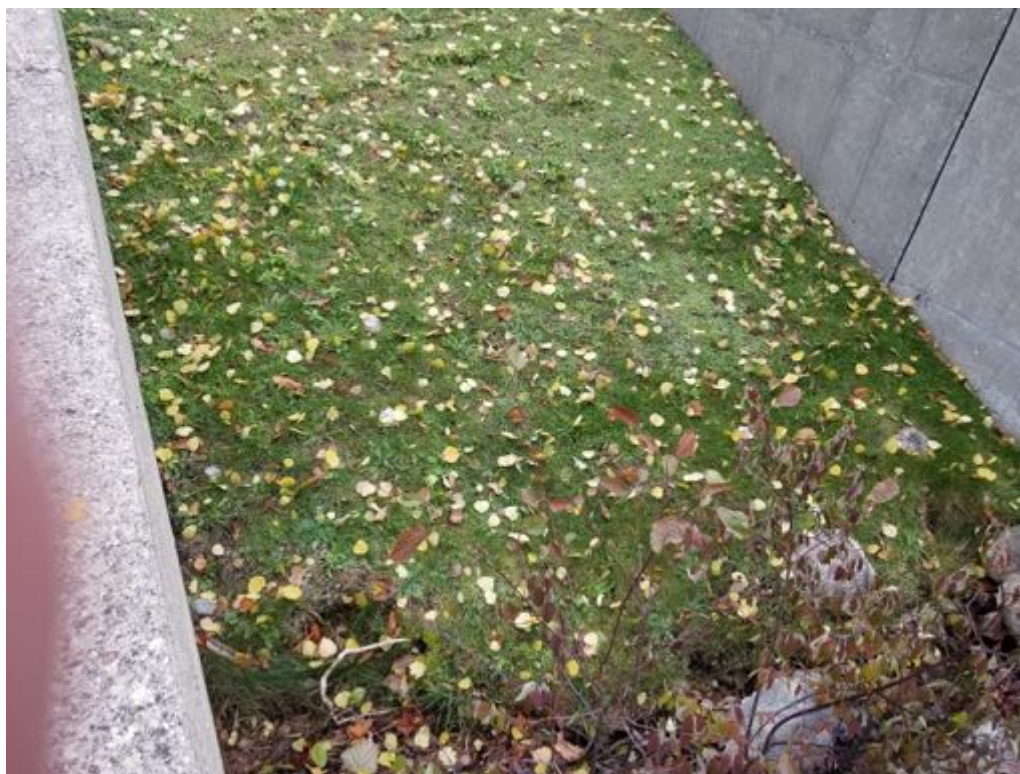
The center embankment is in good condition and covered with grassy vegetation. The prior inspection noted the presence of small woody vegetation at the toe of the dam. This vegetation should be removed before it gets larger.

Middle embankment showing woody vegetation that should be removed
